LOW PERMEABILITY BARRIER AT SUMAS RIVER DIKE BREACH REPAIR ▼

Participants: City of Abbotsford: Tyler Bowie, P.Eng.; Kontur Geotechnical Consultants Inc.: Brian L.J. Mylleville, Ph.D., P.Eng.; Kerr Wood Leidal Associates Ltd.: Colin Kristiansen, P.Eng.; Keller: Brian Wilson, P.Eng.

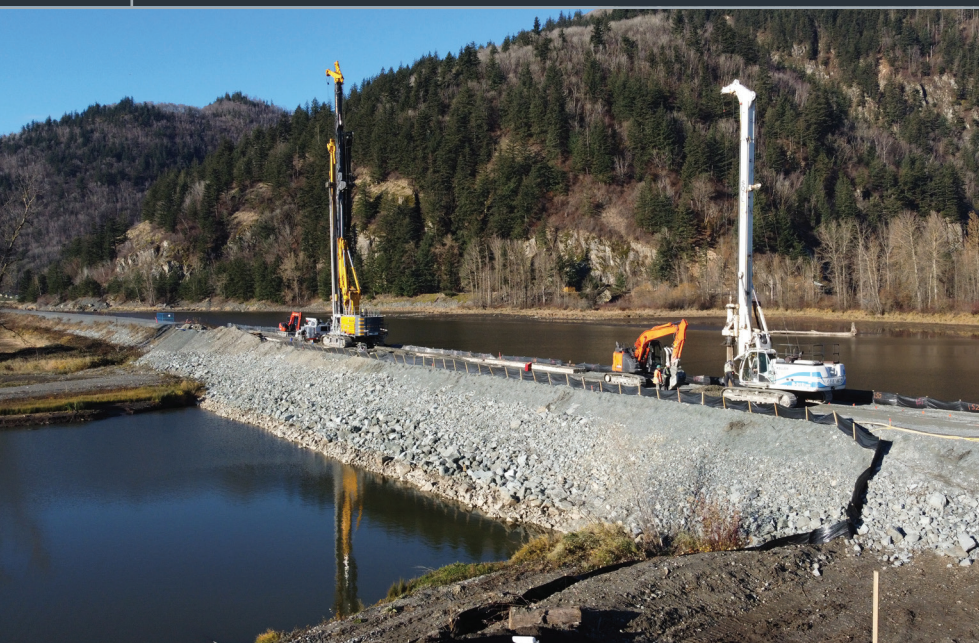
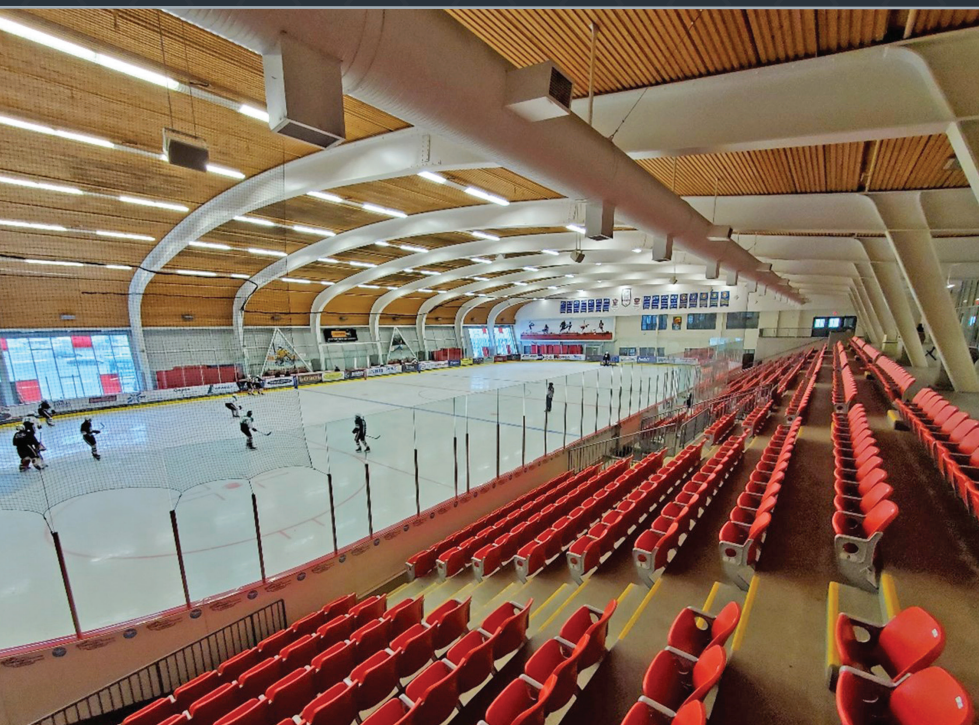
In November 2021, emergency repairs were completed on the Sumas River Dike under flood conditions. Flowing and then standing water precluded the use of fine-grained fill to construct a low permeability barrier (core) as part of the repair. Crushed rock of varying sizes was used to close the dike breach and prevent flows from entering Sumas Prairie. Smaller sized crushed gravel was used within the central zone of the dike repair to facilitate construction of a barrier to mitigate through-seepage. In the fall of 2022, Cutter Soil Mixing (CSM) technology was implemented to re-establish a barrier comprised of the finer crushed gravel, mixed in place with bentonite and Portland cement. CSM technology eliminated the need to deconstruct the initial emergency repair.
