REPAIR OF THE SUMAS RIVER DIKE BREACH ABBOTSFORD, BC

REPAIR OF THE **SUMAS RIVER** **DIKE BREACH, ABBOTSFORD, BC**

Brian L. J. Mylleville

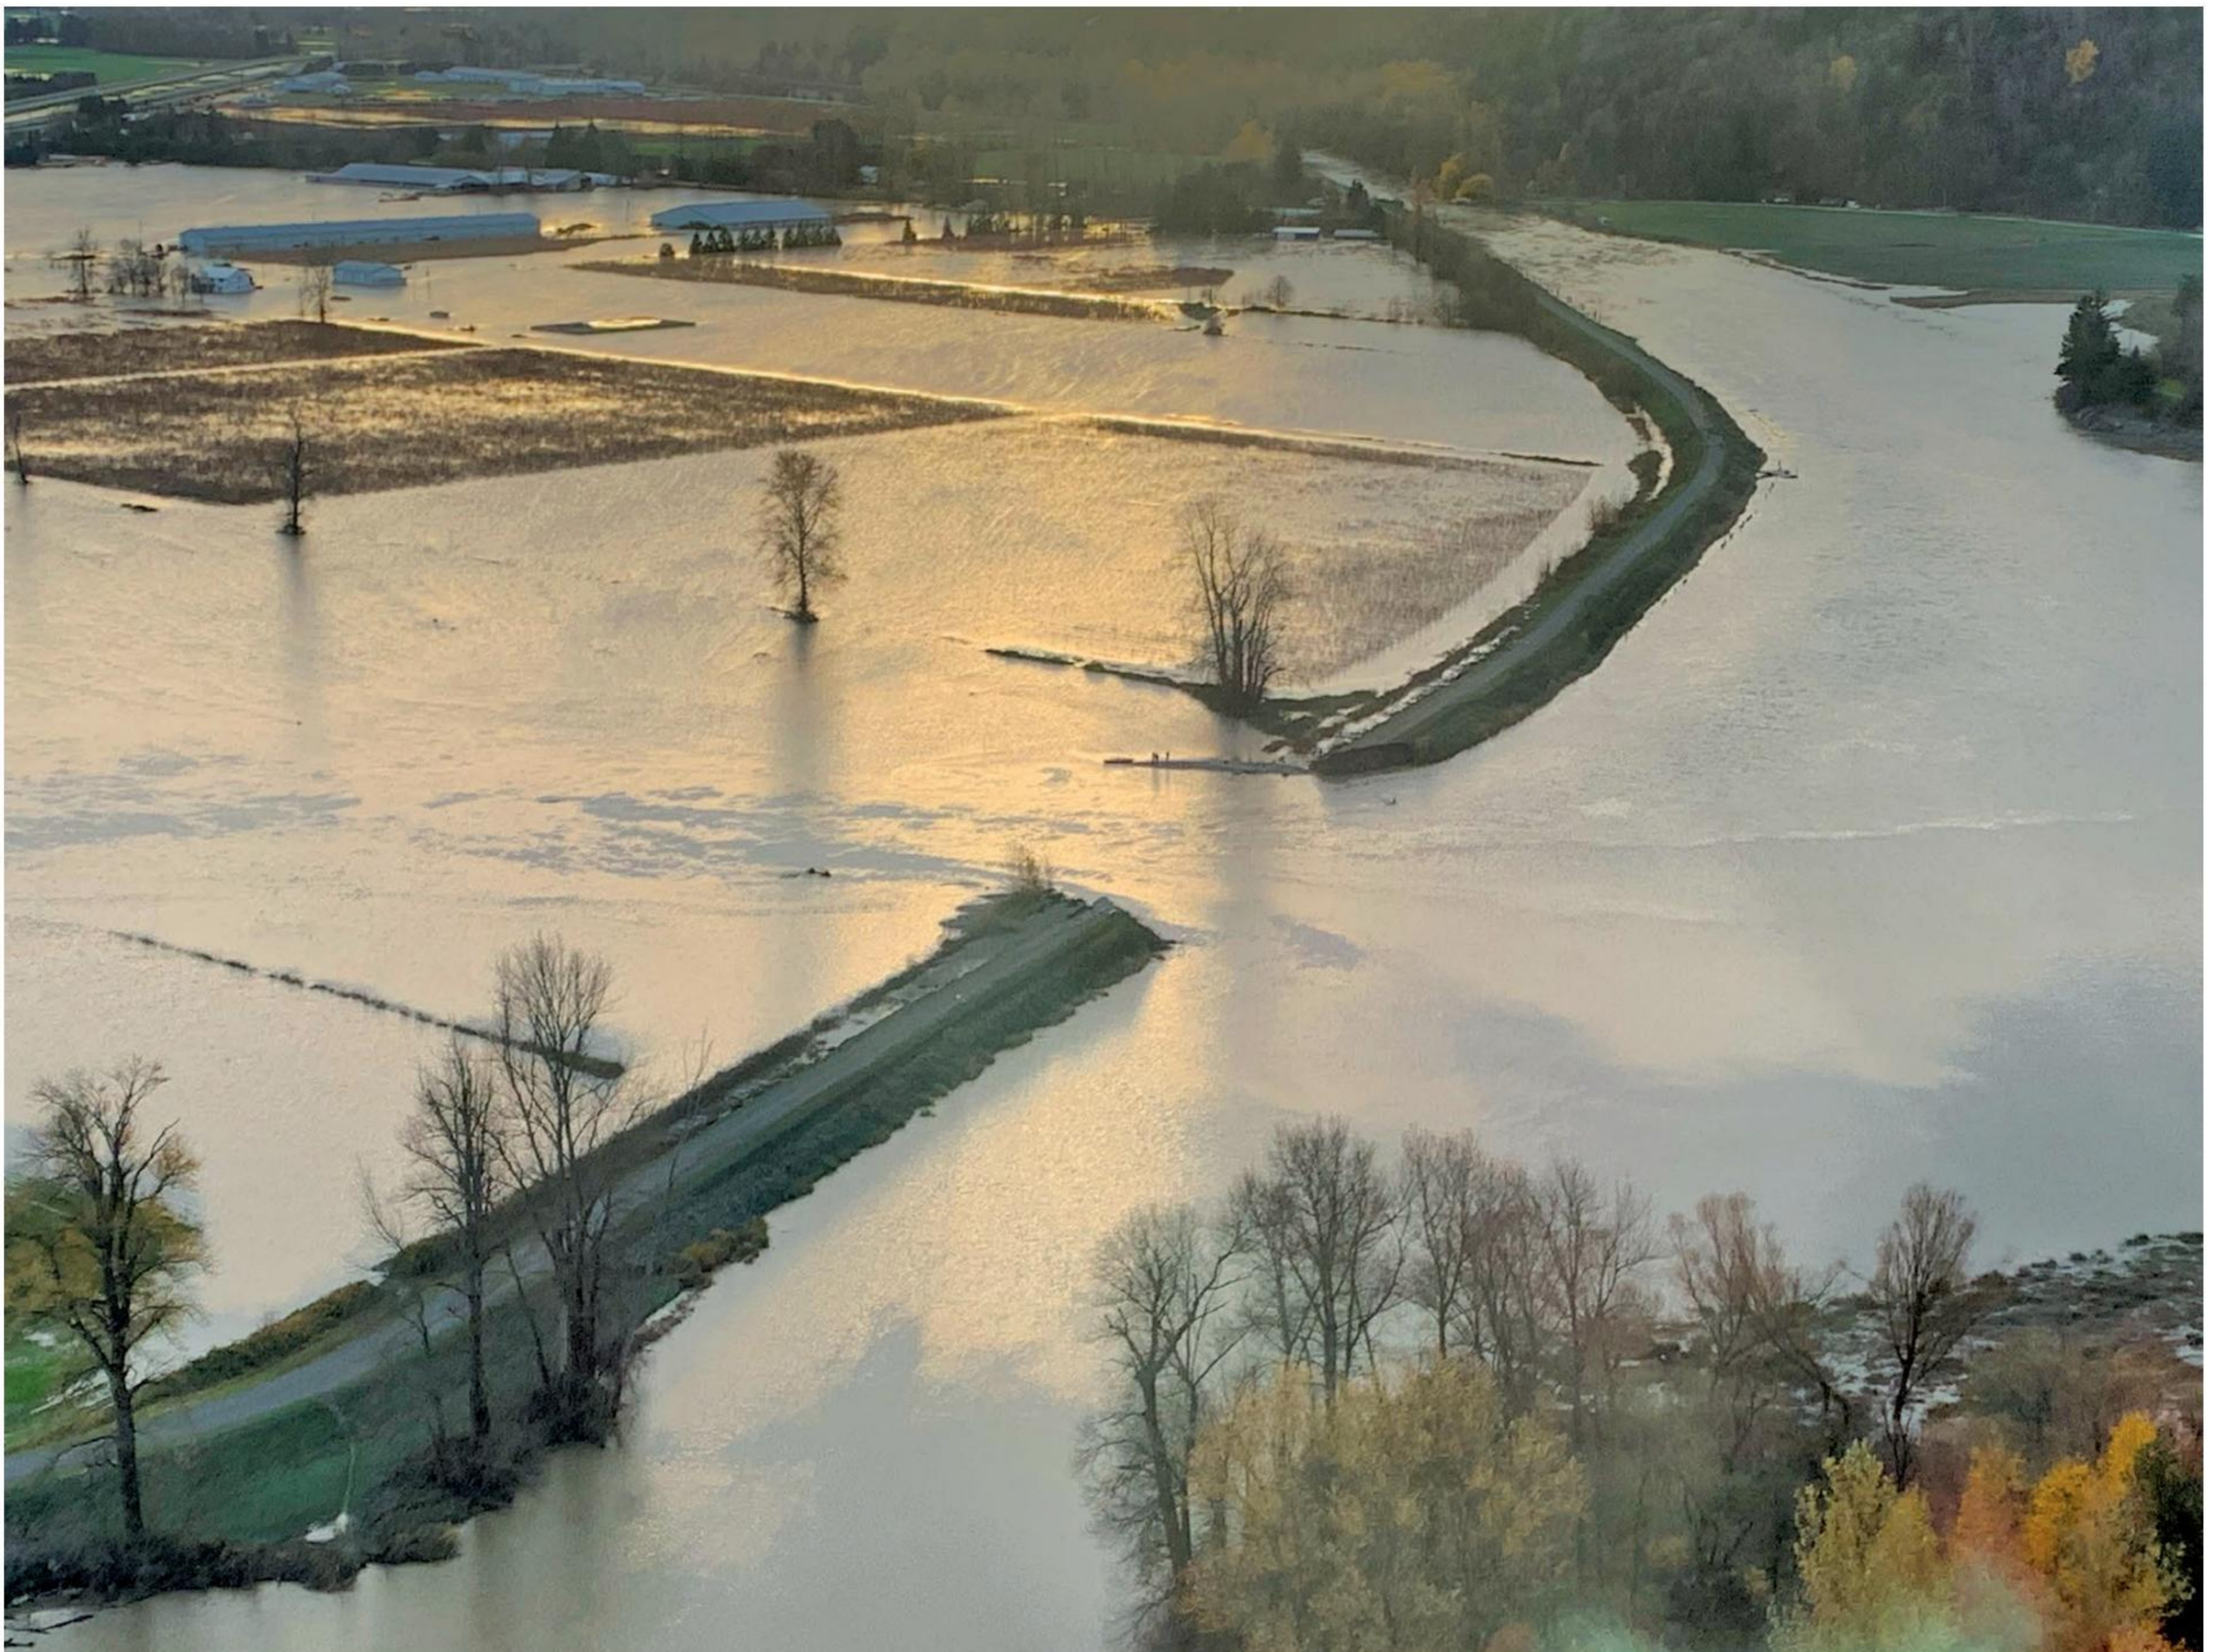
Figure 1. Sumas River Dike breach (water flow from right to left)

The breach occurred because of floodwaters from the Sumas River overtopping the dike followed by rapid downcutting of the dike structure – allowing floodwaters from the Sumas River to flow into the Sumas Prairie (see Figure 1).

At the breach, most, if not all, of the dike structure was lost over a length of about 150 m, with a large scour hole eroded well below the land-side toe of the dike and beyond, extending some 150 m into a farm field to the southeast. The bottom of the scour hole was about 3–4 m below the base (bottom) of the existing dike.

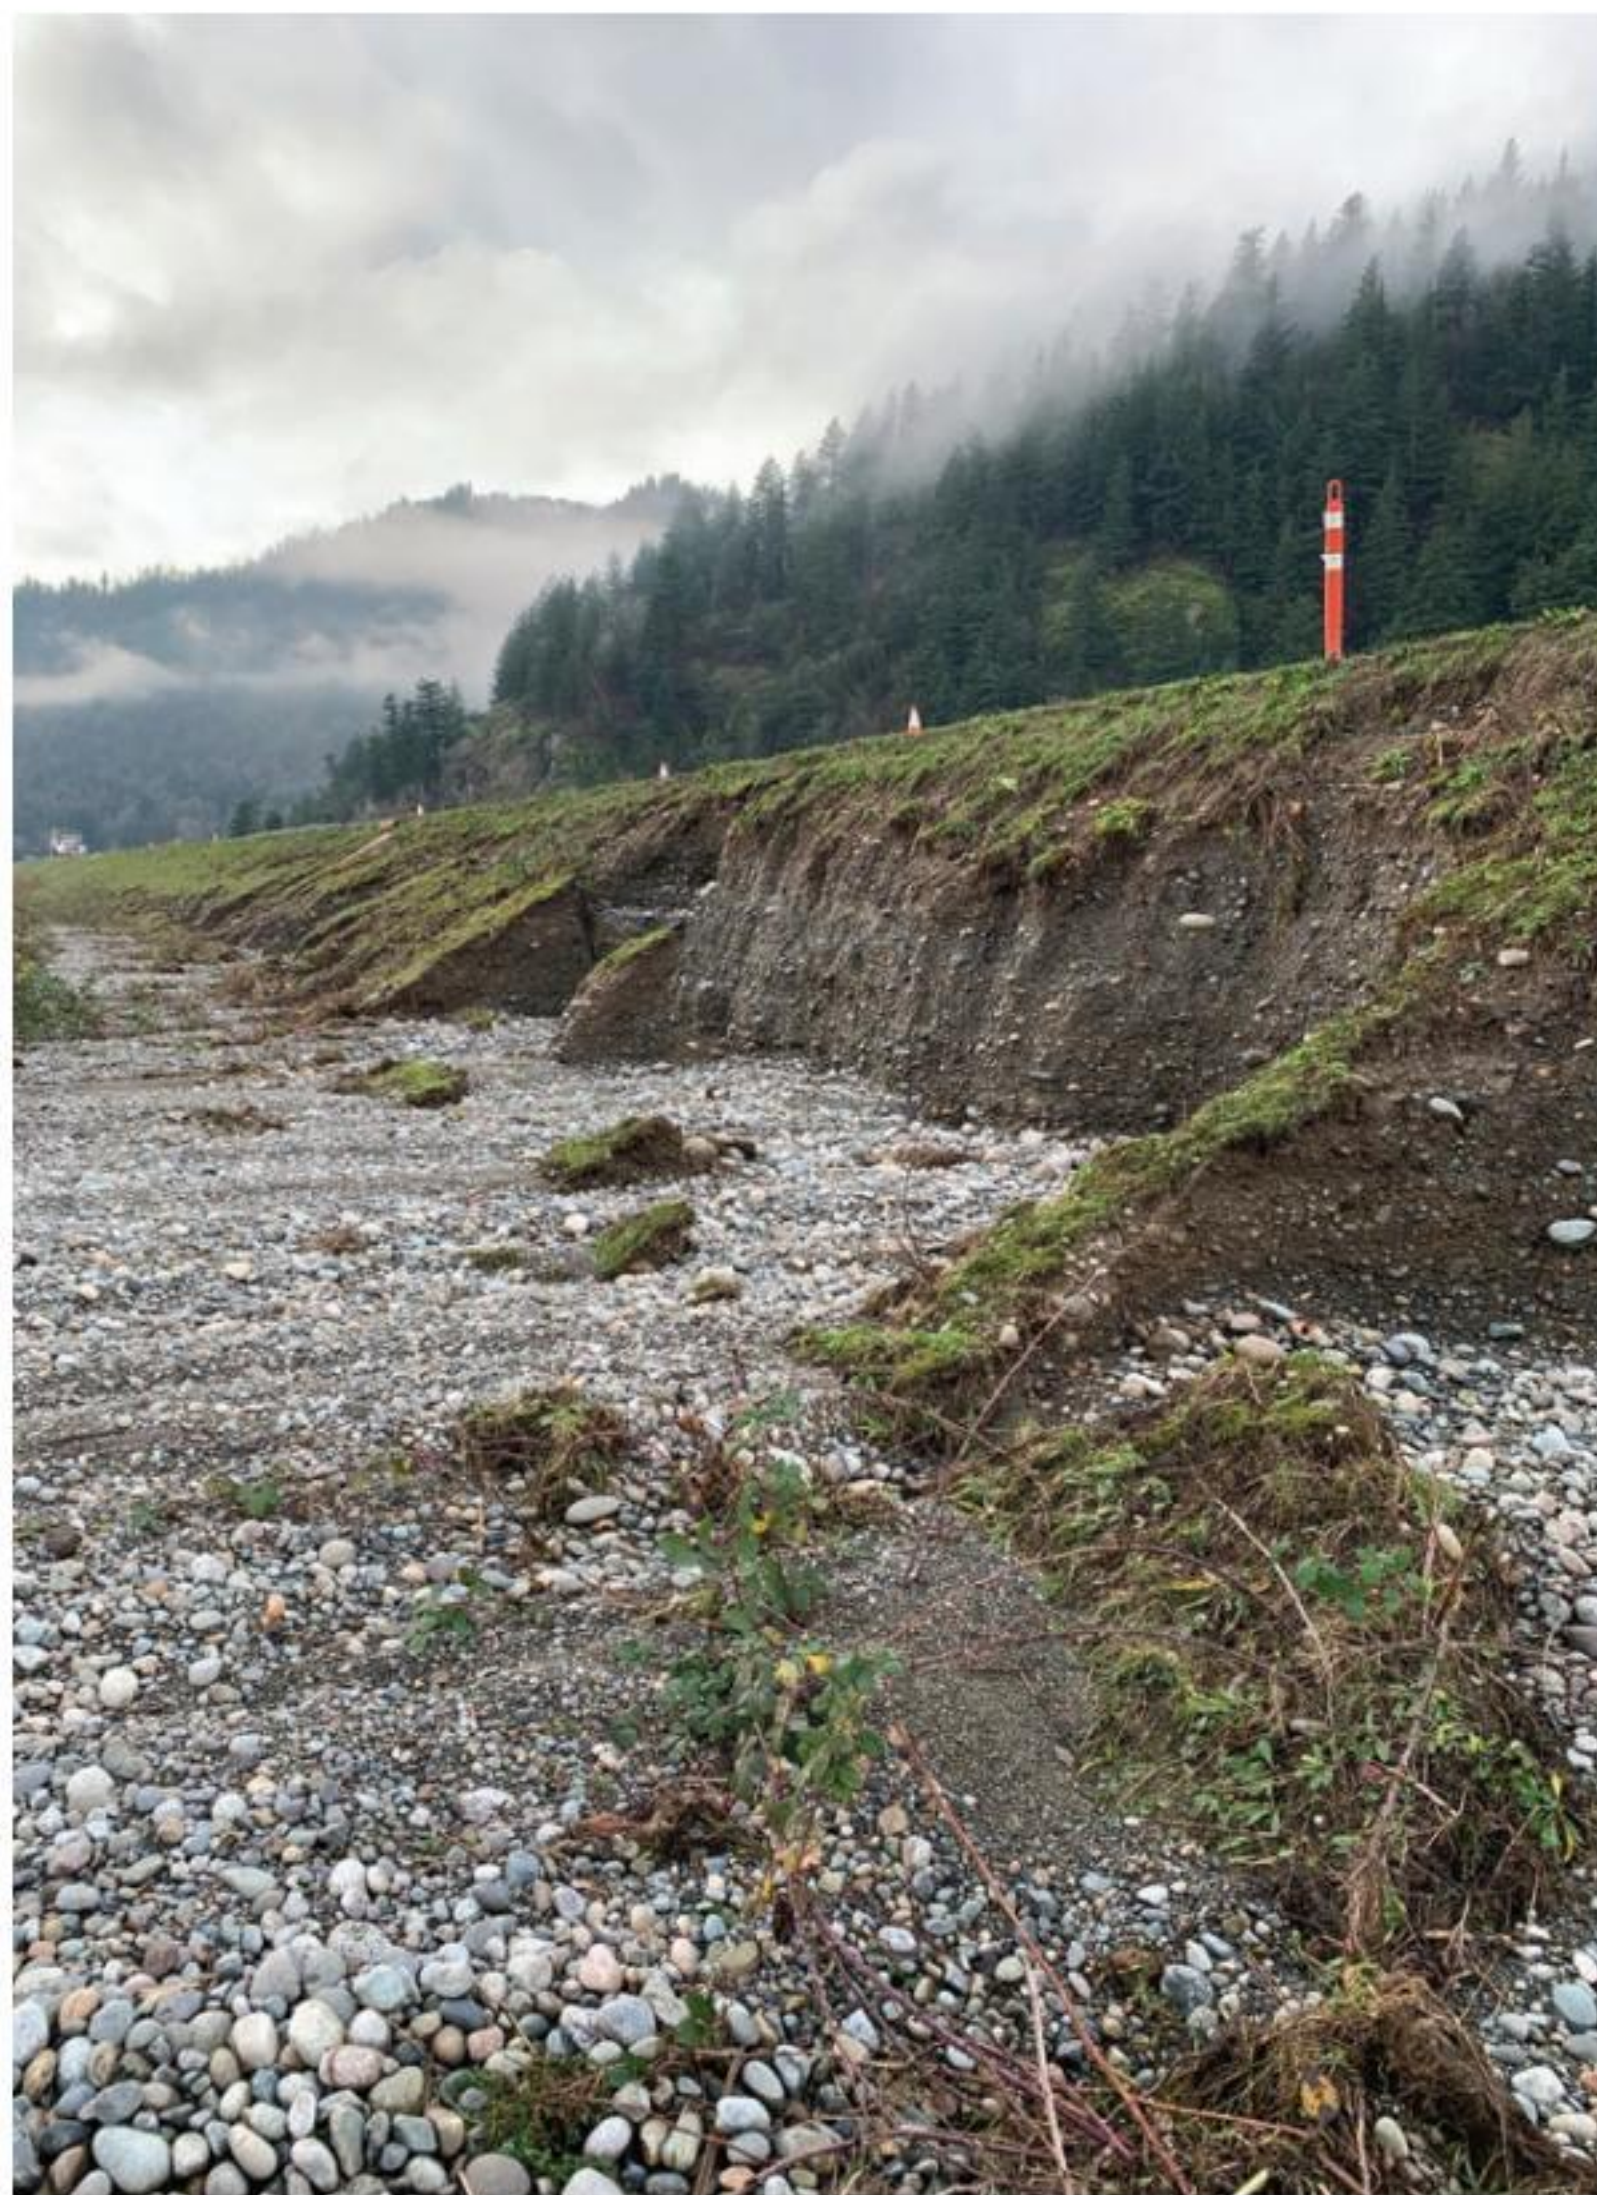
Evidence of significant erosion and downcutting of the landside slopes of the dike

Figure 2. Erosion along the landside slope of the dike near the breach

could be seen with several sections eroded to near-vertical configuration at the landside crest of the dike slope (see Figure 2).

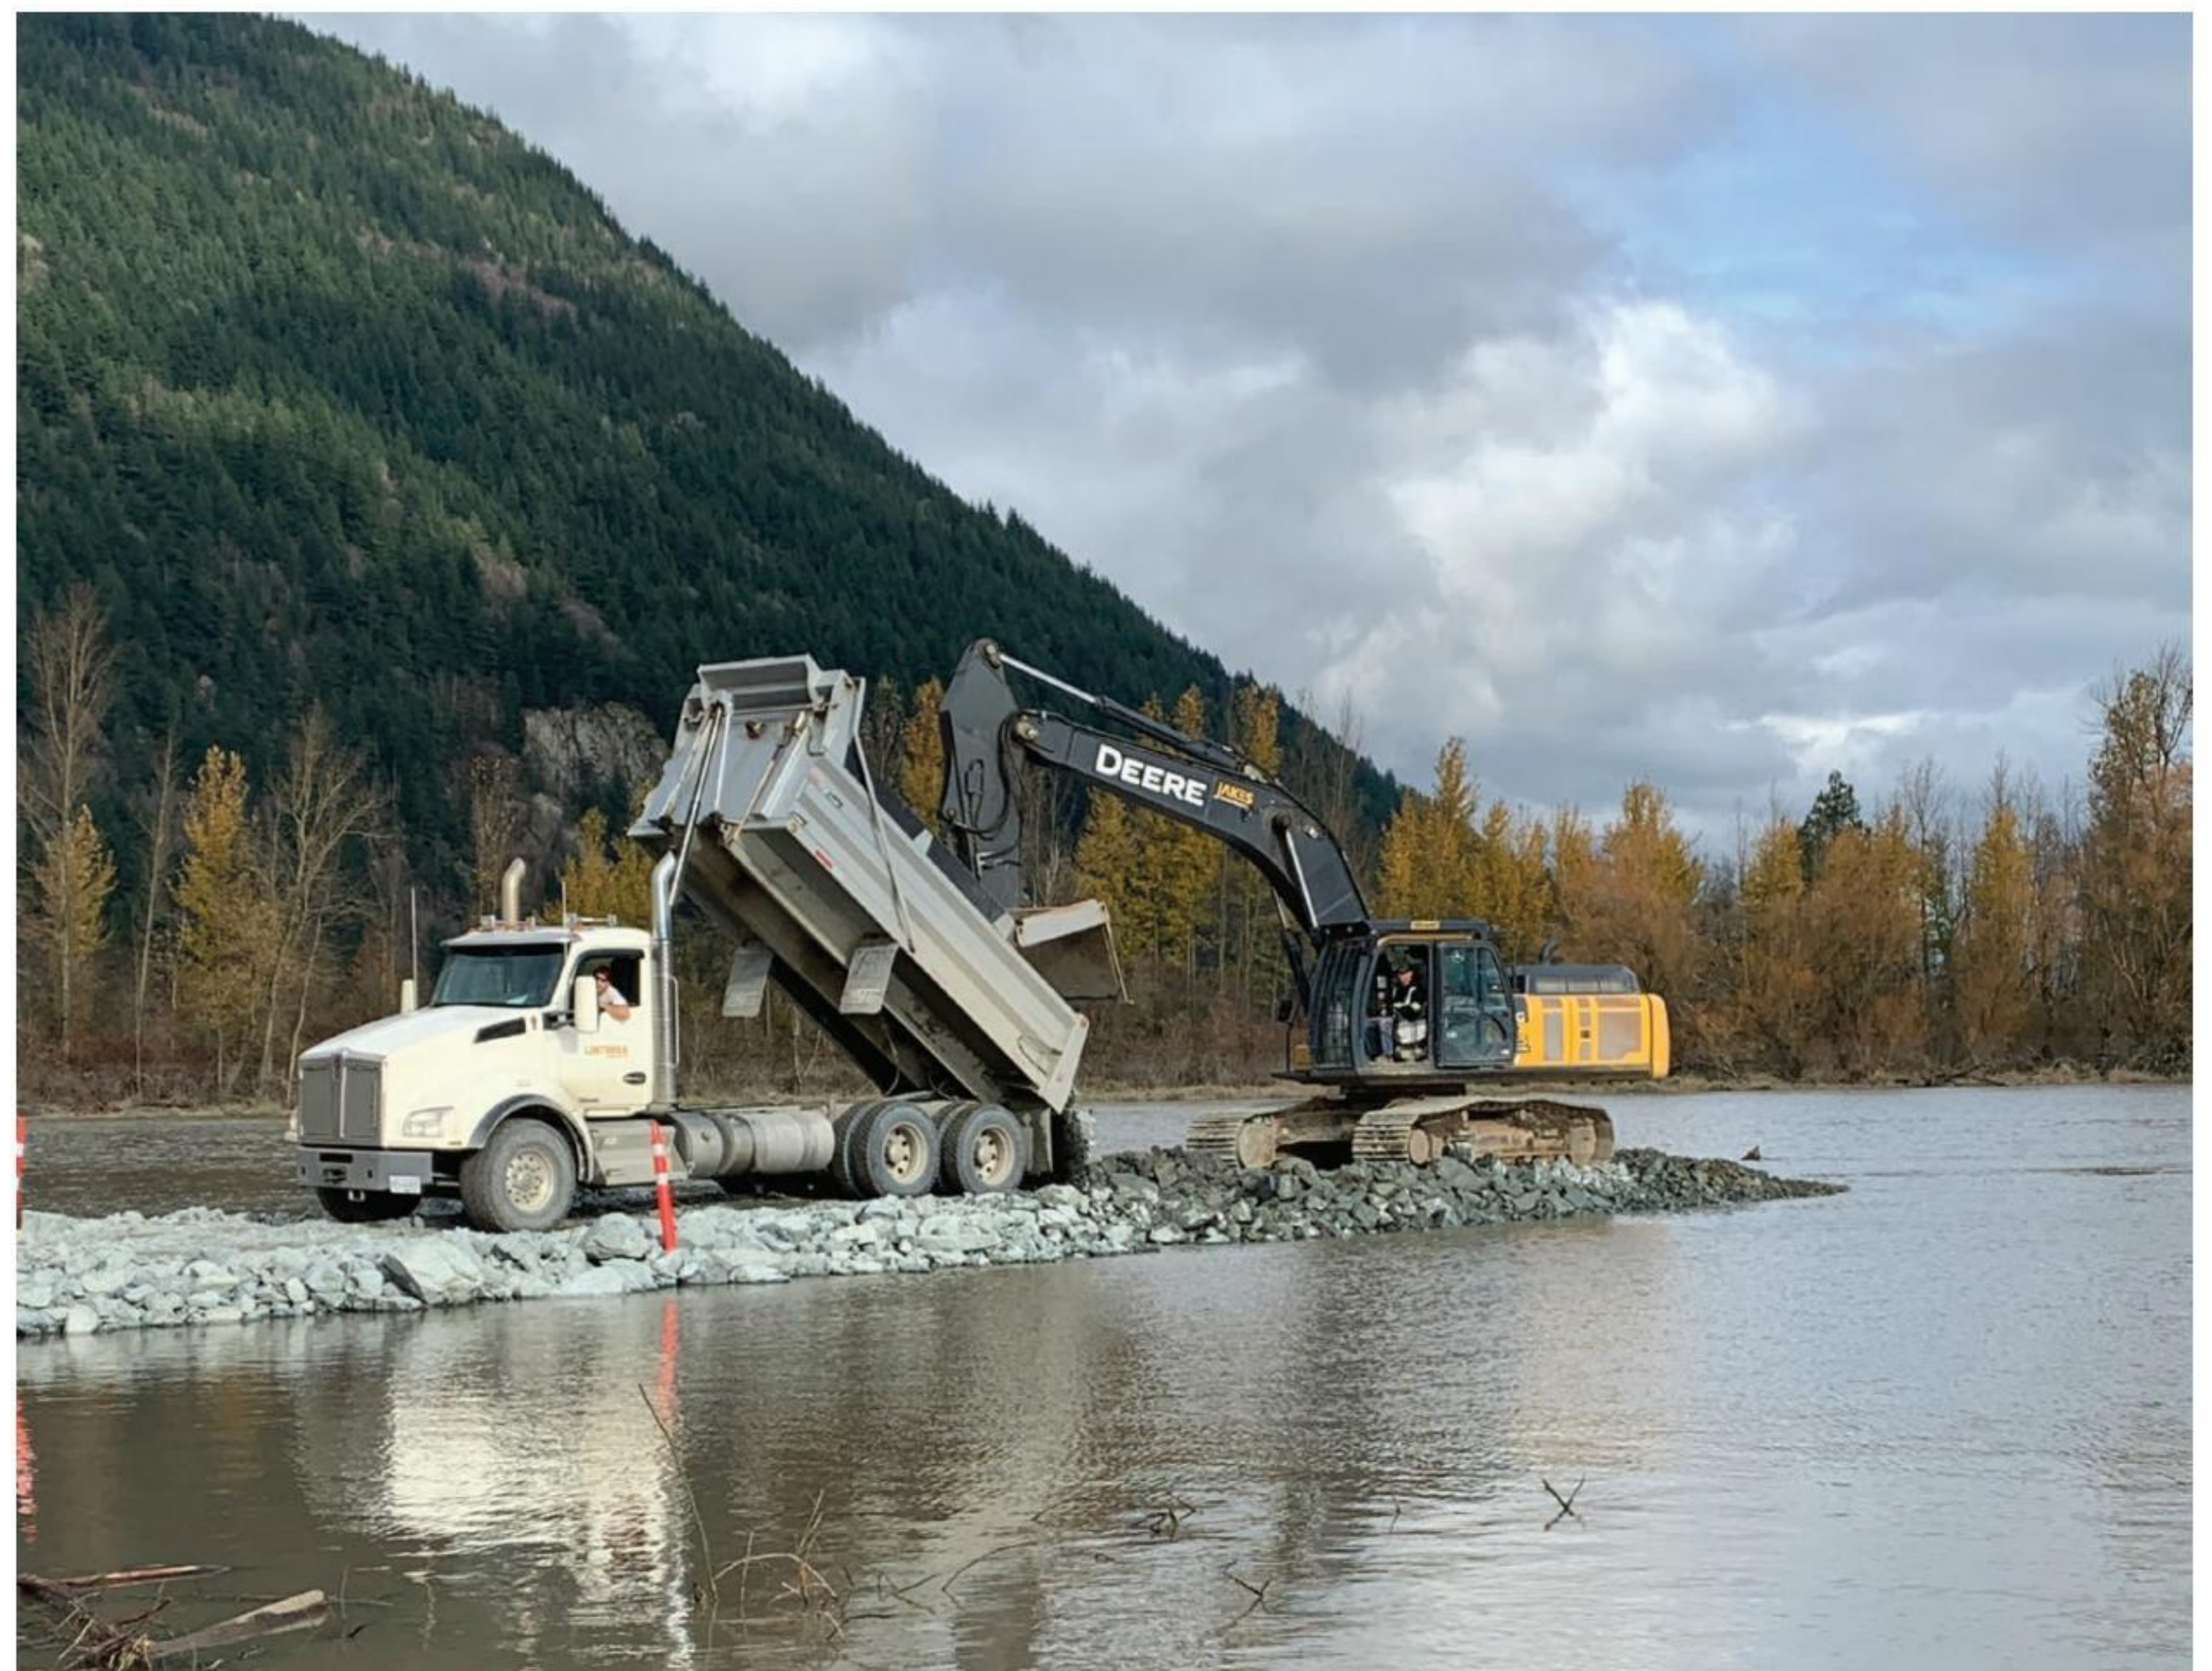
Figure 3. Initial emergency closure of the breach with coarser crushed rock

The approach that was adopted for closure of the breach was to construct an initial crossing to stop flow from Sumas River, then continue to widen and build up or raise the closure once the open flowing water was stopped (see Figure 3). The entire closure of the breach was constructed using crushed granular fill

of varying sizes, with coarser 600 mm minus crushed rock specified for the outside (initial crossing and along the side slopes) and finer 75 mm minus crushed rock specified within the central portion of the dike. The initial closure was widened to the south and raised using the finer crushed rock to allow for future installation of a low-permeability barrier.

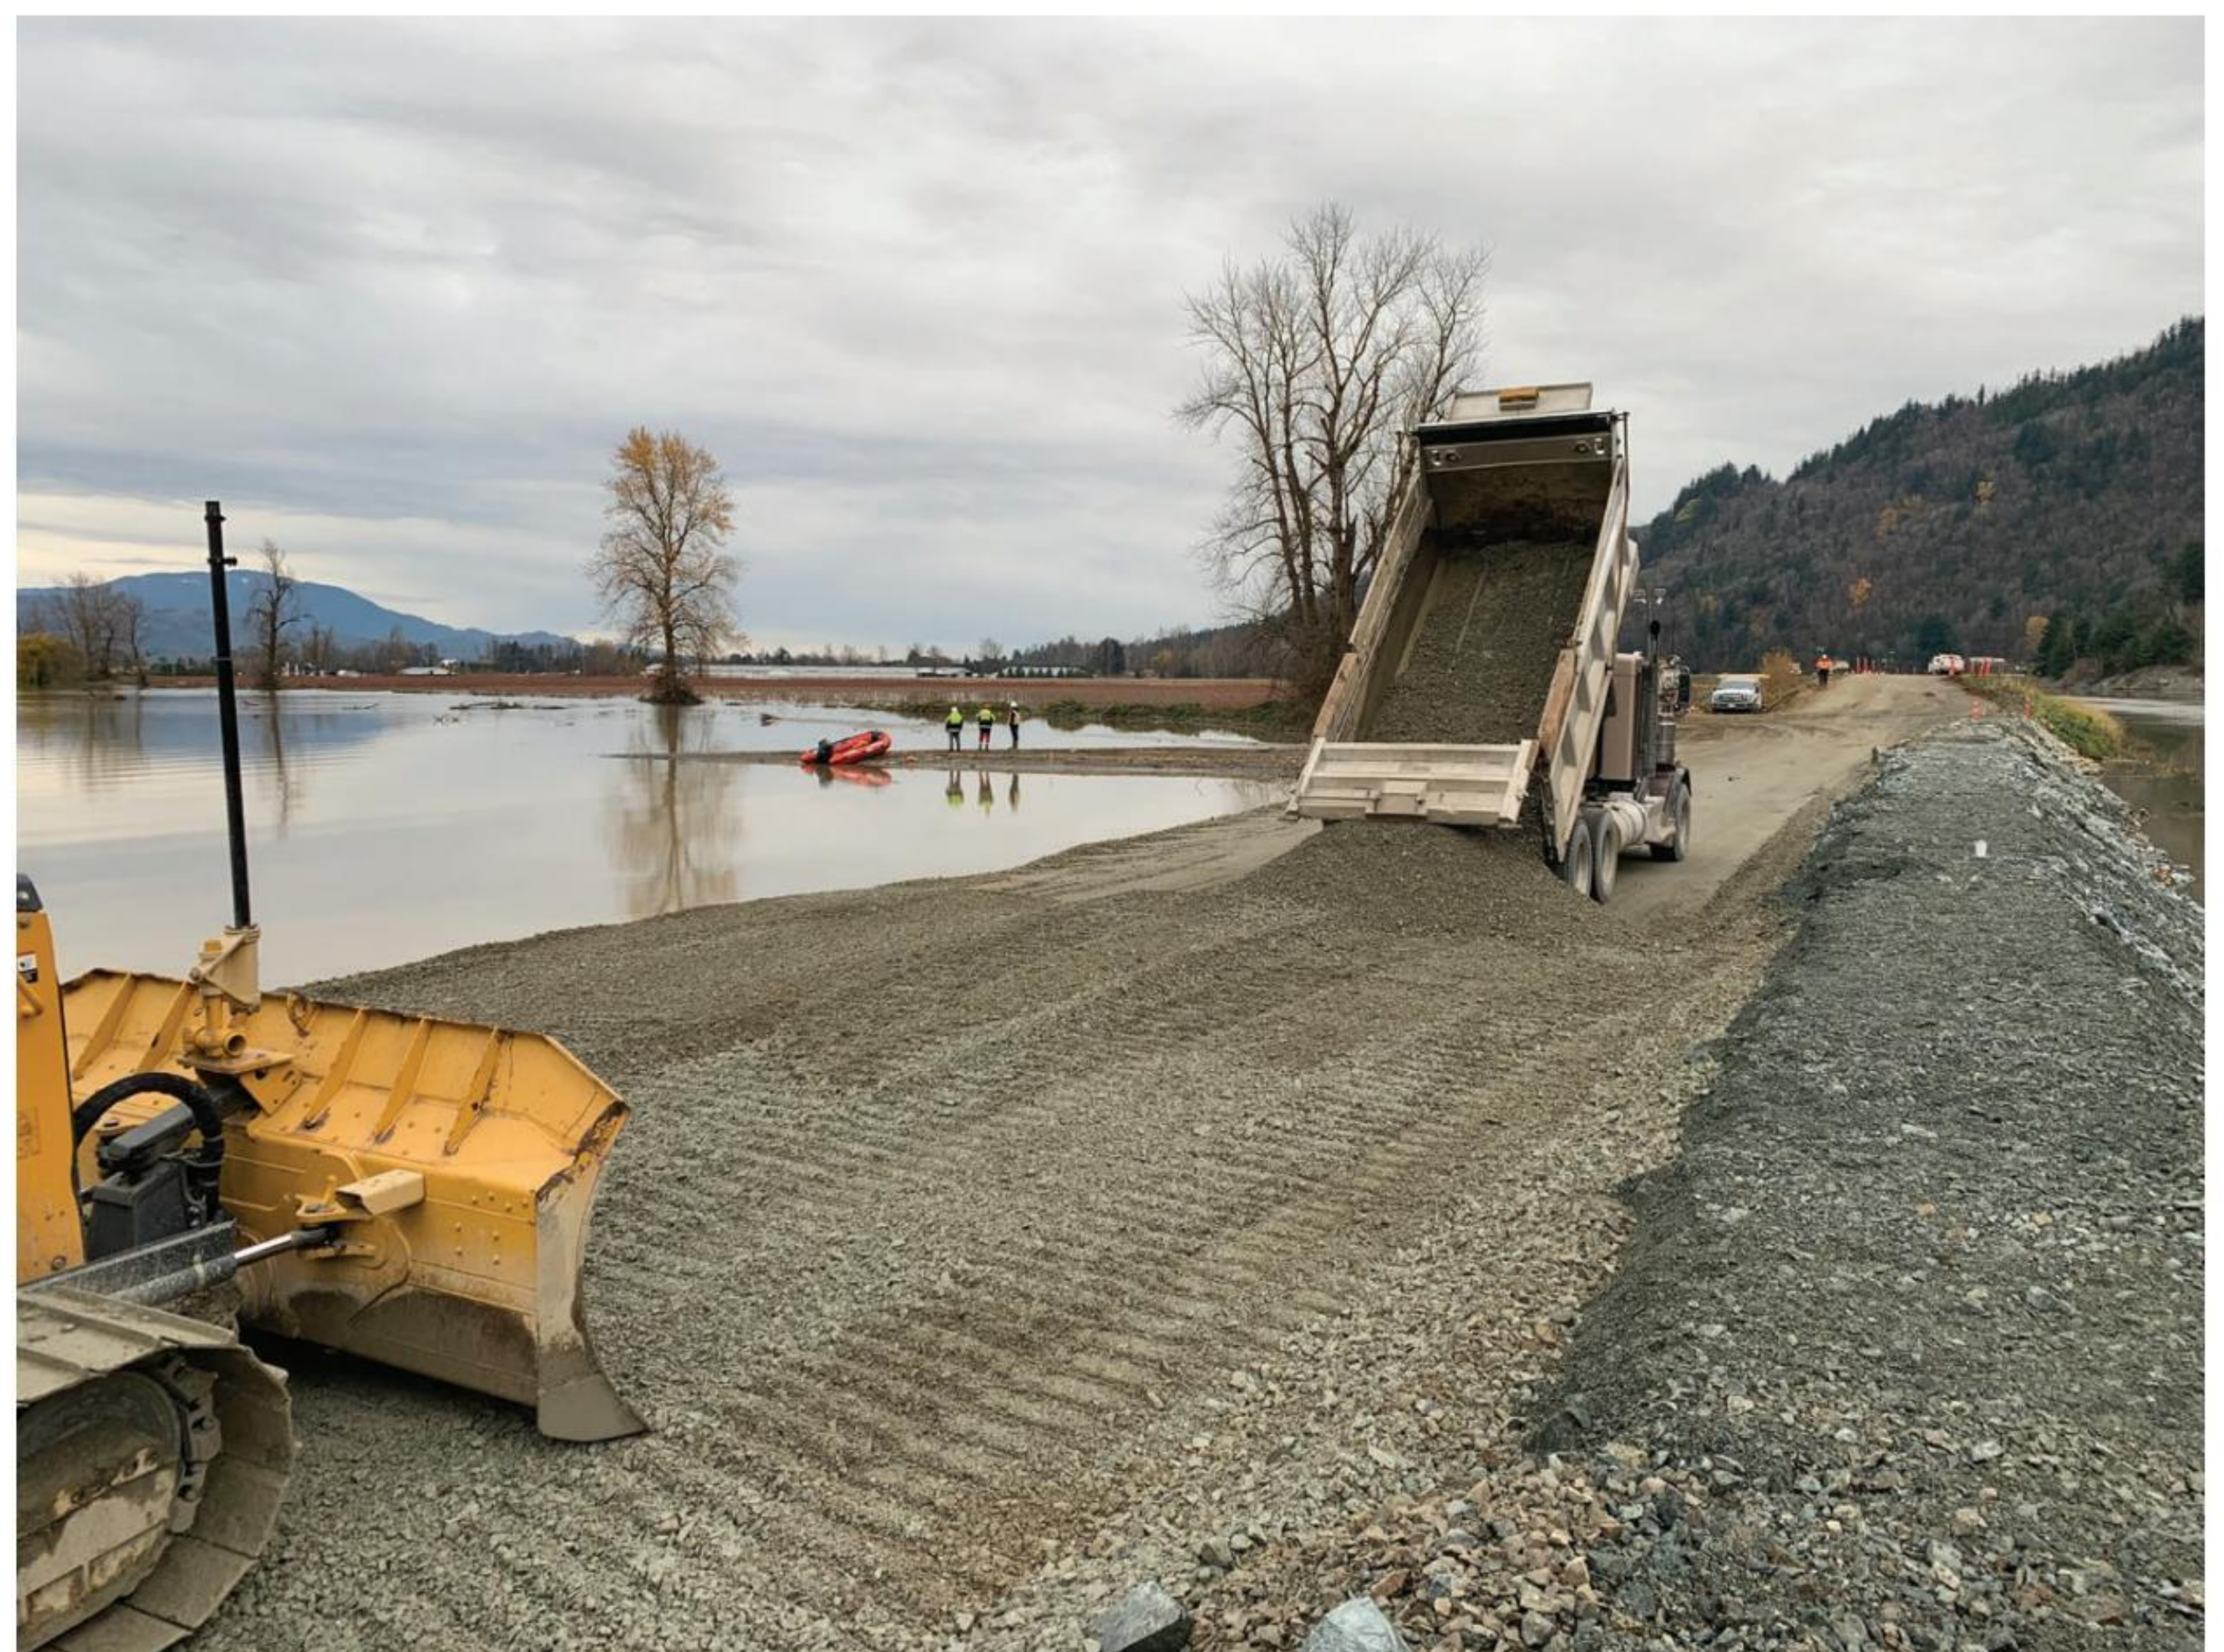
Figure 4. Constructing the central portion of the breach closure with finer crushed rock

The widening and raising of the breach closure continued using the smaller sized crushed rock (see Figure 4). This material was placed in lifts and compacted using a large vibratory compactor. Specifying the use of finer 75 mm minus crushed rock to construct the central portion of the cross-section for the dike closure was essential to provide some

degree of flexibility in terms of considering options to reinstate a low-permeability barrier – without which, the dike would have continued to leak. Coarser crushed rock fill was then placed along the land-side slope of the closure to support the finer fill material within the centre of the closure. The initial emergency closure of the dike breach was completed in late November 2021.

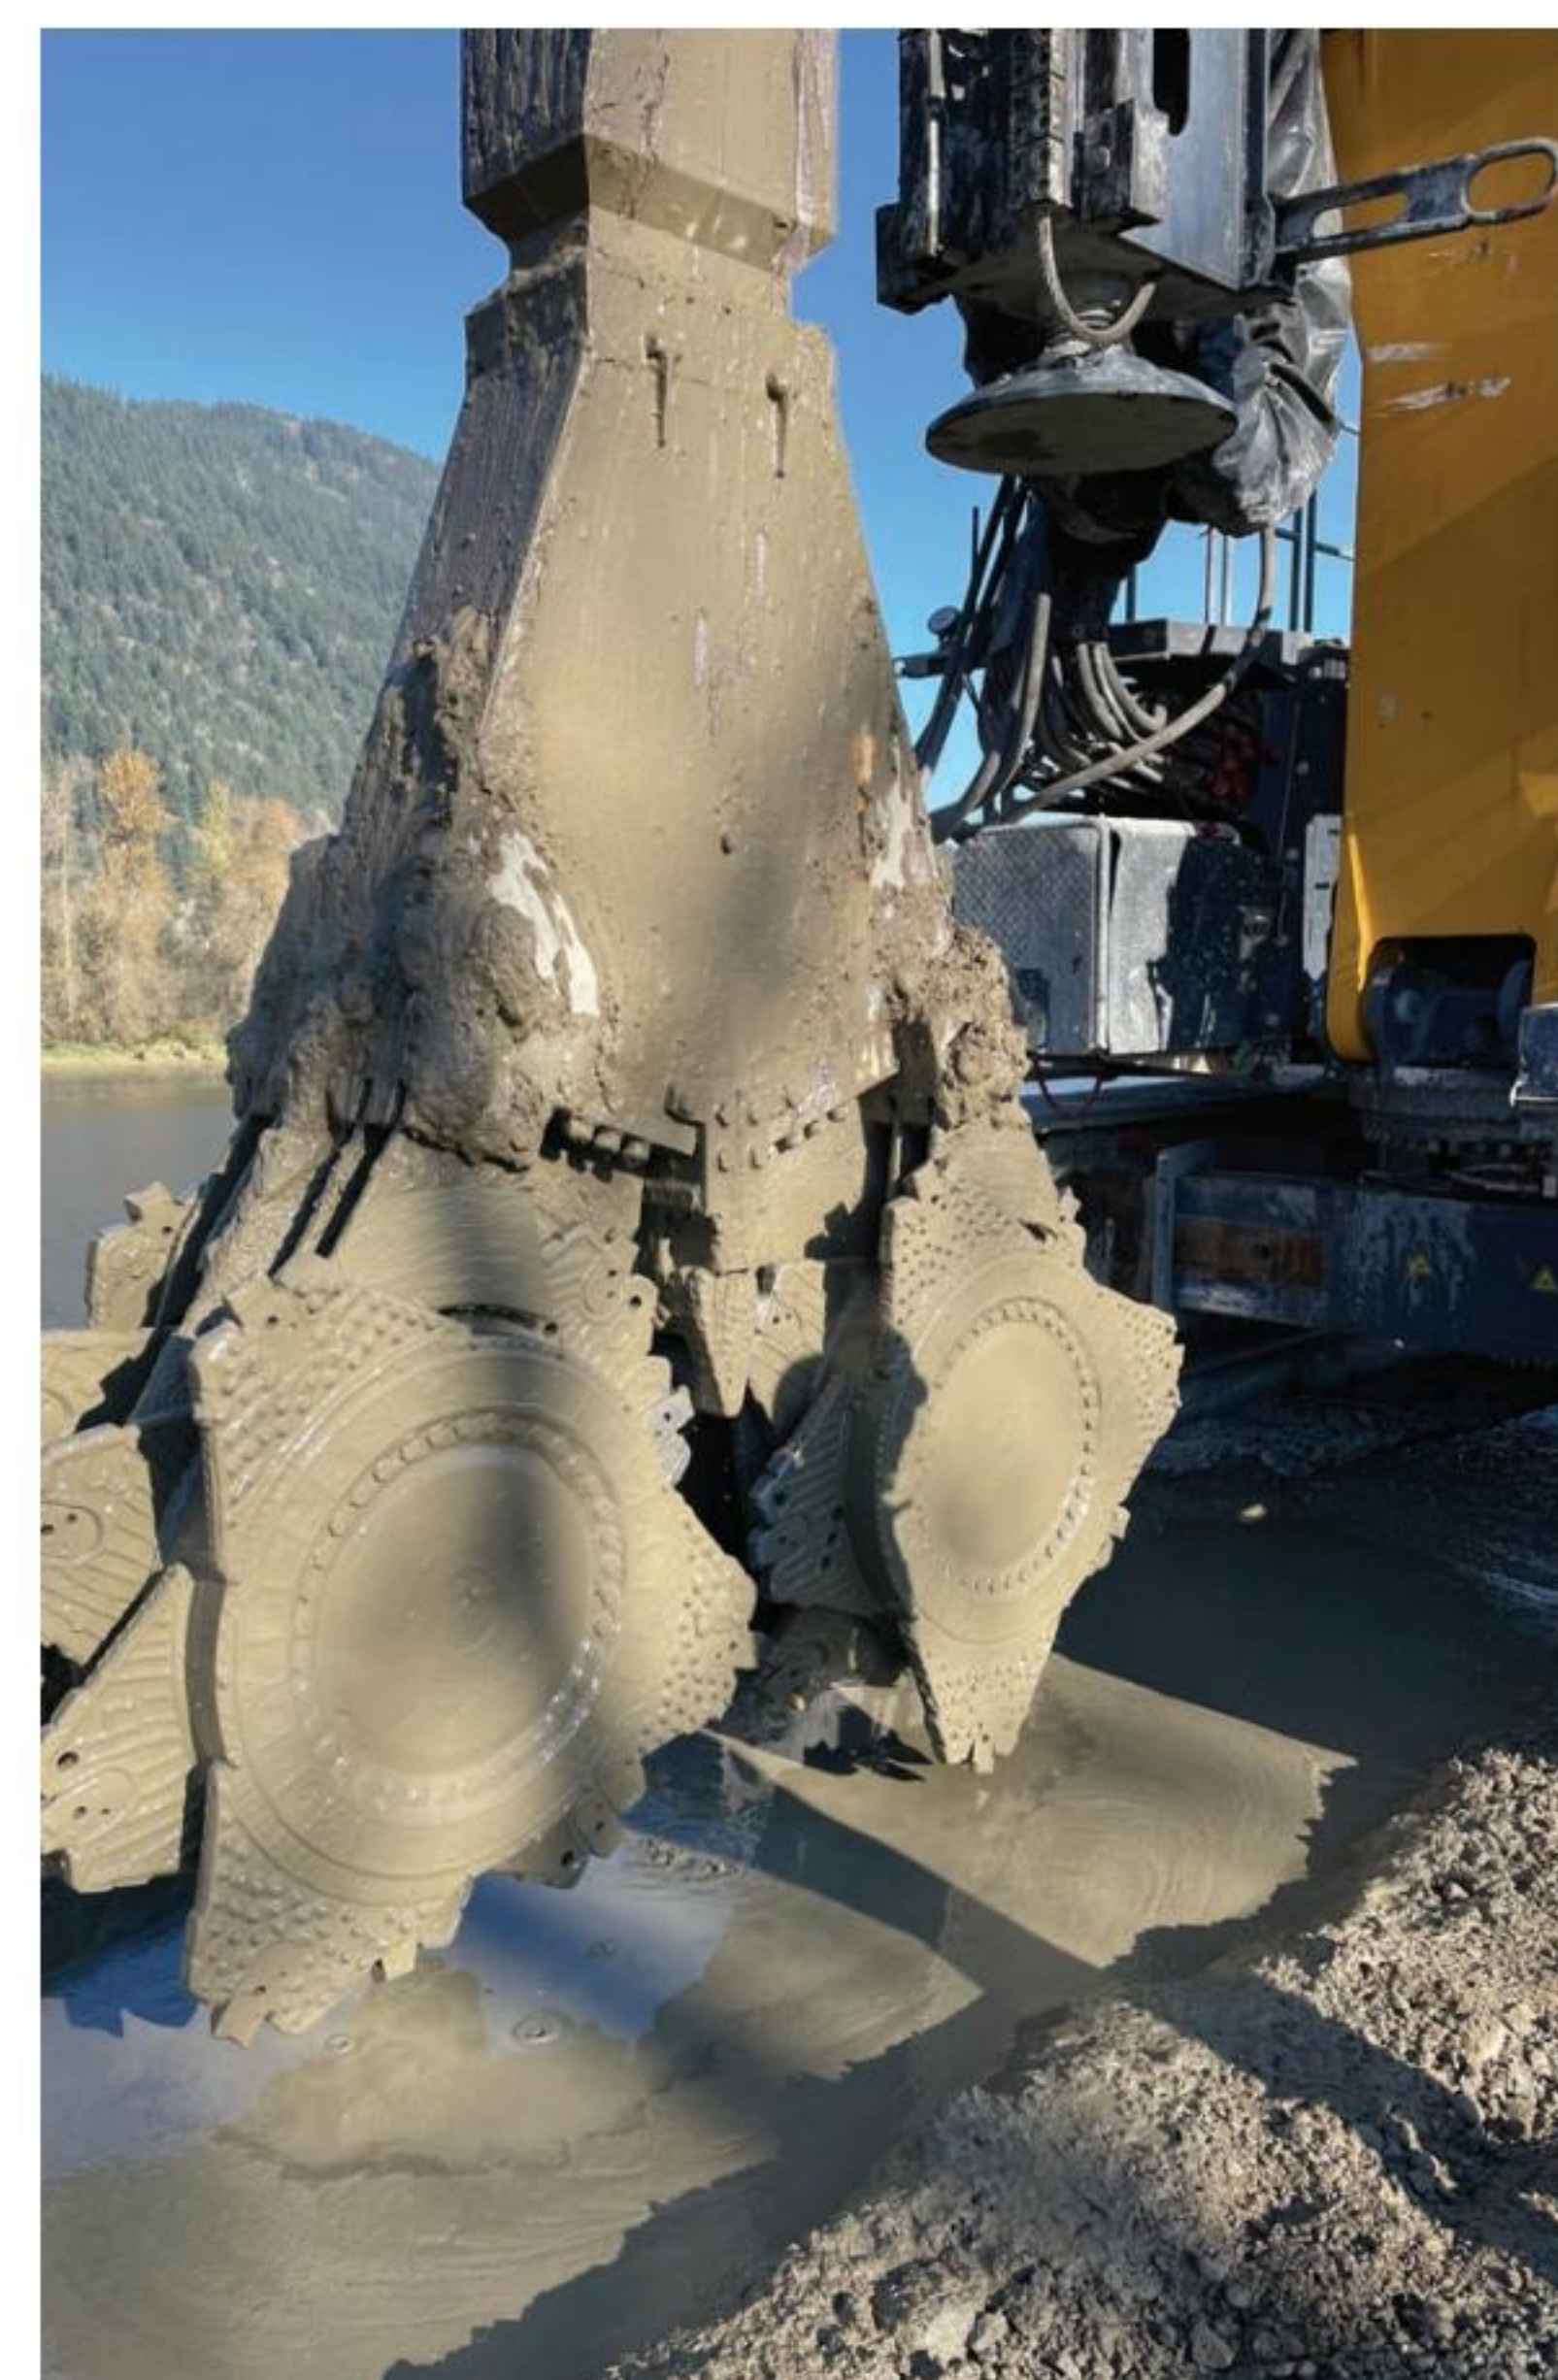
Figure 5. CSM cutting tool being retrieved from the ground following completion of a CSM panel

The CSM process employs a cutting tool comprising counter-rotating drums fitted with cutting teeth with a configuration that is designed for cutting and mixing in-situ soils with bentonite and Portland cement slurries – to construct rectangular panels 2.8 m long by 640 mm wide extending to the target depth. As the cutting tool advances or cuts its way down into the ground, bentonite slurry is continually added to aid as a cutting fluid and to lower the permeability of the mixed soil-slurry mass. When the cutting tool reaches the target depth, Portland cement slurry (required for strength) is then introduced as the cutting tool is slowly retrieved from the ground. The contractor tailors the bentonite slurry and Portland cement slurry application to achieve the performance requirements set out in the contract specifications. Figure 5 shows the cutting tool being retrieved from the ground following completion of a CSM panel.

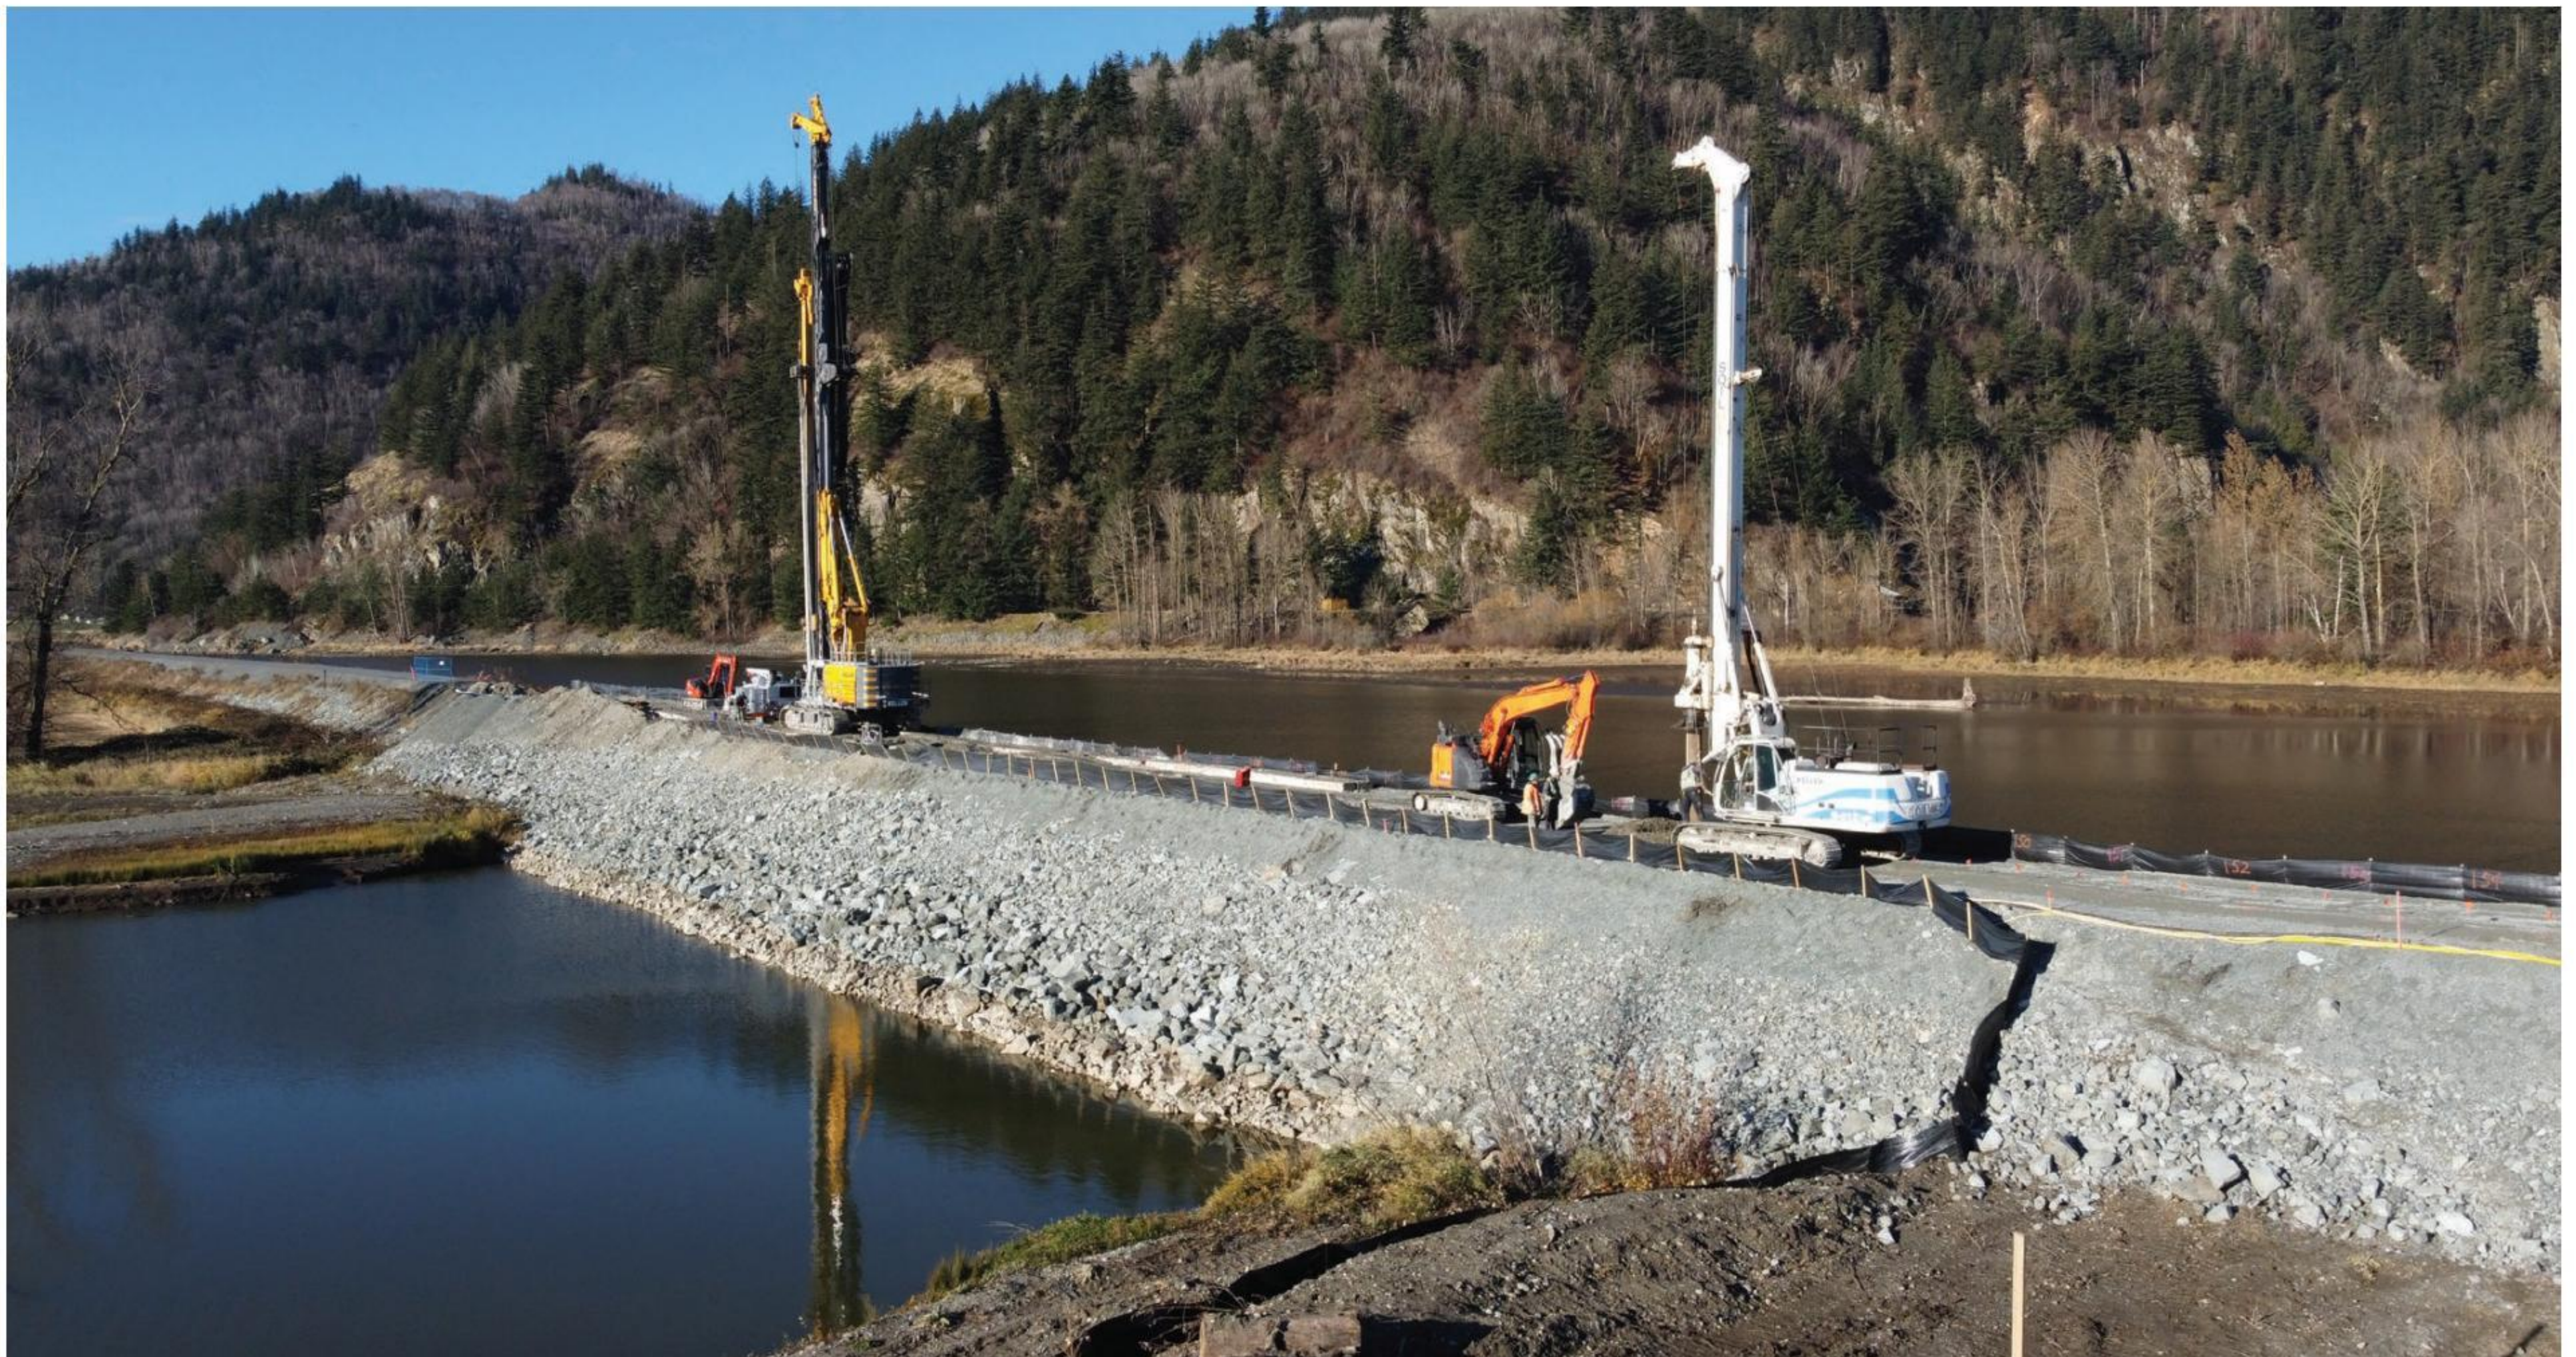
Despite best efforts during construction of the initial emergency closure to keep the zone of the central finer crushed rock separate from the outer coarser crushed rock, larger pieces of crushed rock were encountered by the CSM cutting tool, resulting in cutter teeth breakage and construction delay. To alleviate equipment damage and delays, predrilling (with casing) was used to remove larger rock fragments prior to installing the remaining CSM panels.

Figure 6. CSM rig and predrilling equipment on the dike breach closure

Figure 6 shows both the CSM rig (yellow) and pre-drilling equipment (white) on top of the dike breach closure with the water-filled scour hole in the foreground and Sumas River and Sumas Mountain in the background.

A total of 60 CSM panels were required to construct the low-permeability barrier, with depths varying between 5.25 and 12.75 m as measured from the top of dike. Construction of the CSM barrier was completed in December 2022.
