Considerations in the design and construction of dike breach repairs

Brian L.J. Mylleville, Ph.D., P.Eng. Senior Geotechnical Engineer, Kontur Geotechnical Consultants Inc.

Dike Breaches – Sumas River Dike, Abbotsford, BC

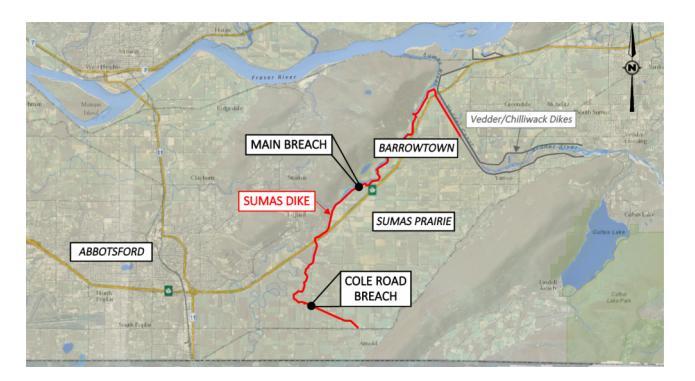
In recent years, the increased occurrence of unprecedented weather events has resulted in catastrophic failure of key infrastructure including flood control structures such as dikes. In November 2021, a series of atmospheric river events resulted in failure of the Sumas River Dike at two (2) locations; the main breach occurred approximately 4.5 km southwest (upstream) of the Barrowtown Pump Station and second smaller breach occurred at Cole Road, south of the Trans-Canada Highway (Highway 1) as shown on Fig. 1. The events also resulted in erosion and/or partial washing out of the water side slope at several sections of the dike.

Fig 1. Sumas River Dike breach locations.

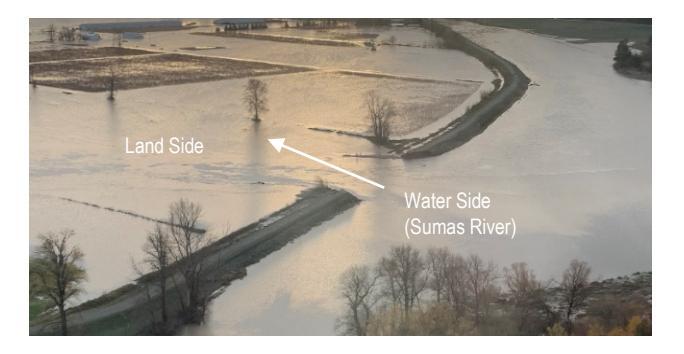
An aerial view of the main breach along the Sumas River Dike is shown on Fig. 2 and the Cole Road Breach is shown on Fig. 3. As previously noted, these two breaches occurred because of floodwaters overtopping the dike followed by rapid downcutting of the dike structure.

Fig 2. Aerial image of the main breach looking southwest.

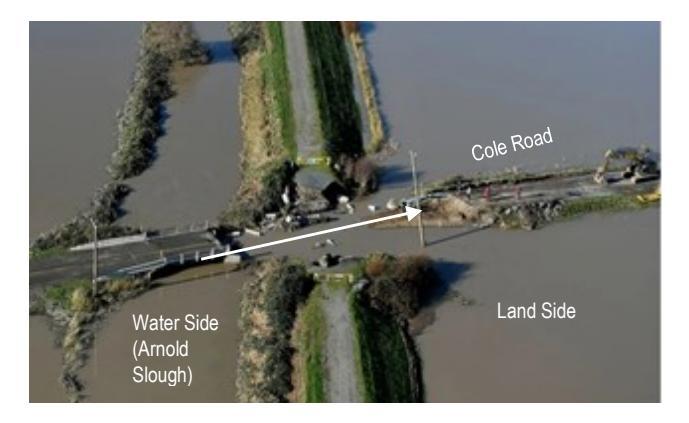
Fig 3. Aerial image of the Cole Road breach looking northwest (Photograph: Vancouver Sun)

A similar geometry for the dike breach and scour hole was not observed at the Cole Road Breach which is likely due to the existing bridge abutment and Cole Road situated on the water and land sides of the breach, respectively (see Fig. 3).

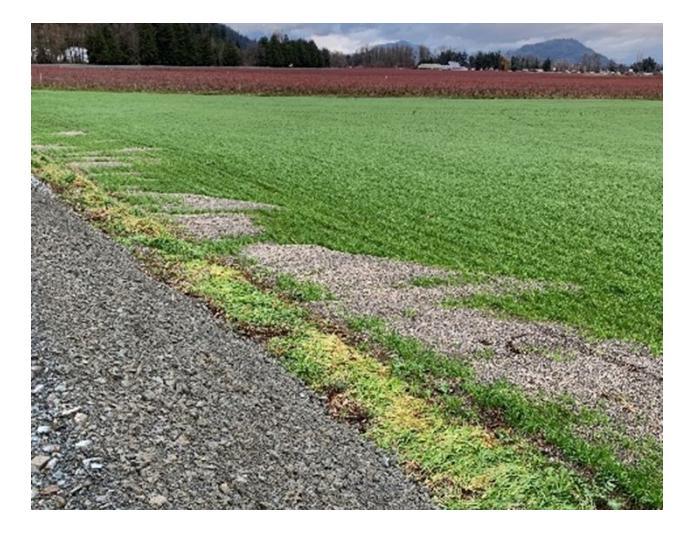
The Sumas Breach was video recorded by the farmer who lives immediately east of the breach location which showed overtopping and downcutting of the dike. Other evidence of overtopping and initial formation of other potential breaches was observed as pinnacles of gravel deposited onto farm fields (see Fig. 4) and near vertical scarps eroded into the landside dike slopes as flood water cascaded over top of the dike (see Fig. 5).

Fig 4. Pinnacles of gravel deposited onto farm fields.

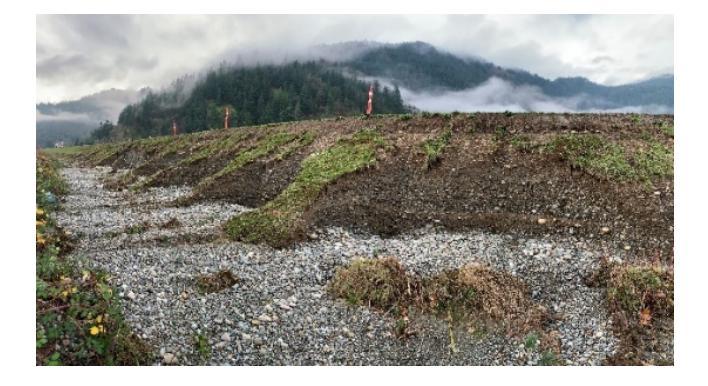
Fig 5. Near vertical scarps eroded into landside dike slopes.

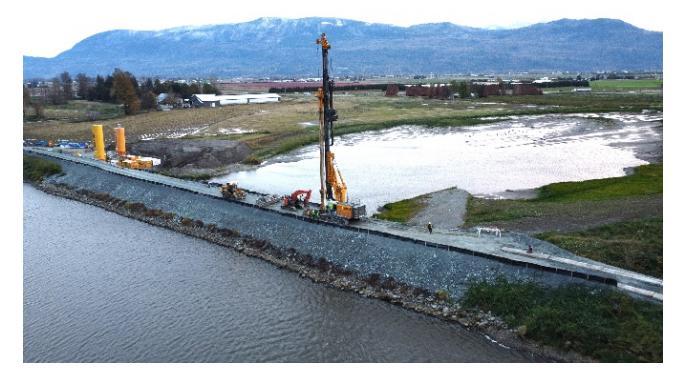
At the main breach, the Sumas River Dike is constructed primarily of silt and sand that was later upgraded with a drainage zone on the landside that was constructed of sand and gravel. The geometry of the main breach was consistent with that shown in Fig. 7 but by coincidence and with some help from Mother Nature. An aerial photograph of the main breach under repair is shown on Fig. 8. Note the brush that remains in place near the toe of the waterside dike slope following the breach event. In essence, the line of brush and its root system acted as natural toe protection and prevented propagation of the breach scour hole into the Sumas River. In addition, this protected edge would aid in construction of the initial closure of the main beach.

Fig 8. Remaining brush along toe of the waterside dike slope at the main breach (Photograph: Kerr Wood Leidal)

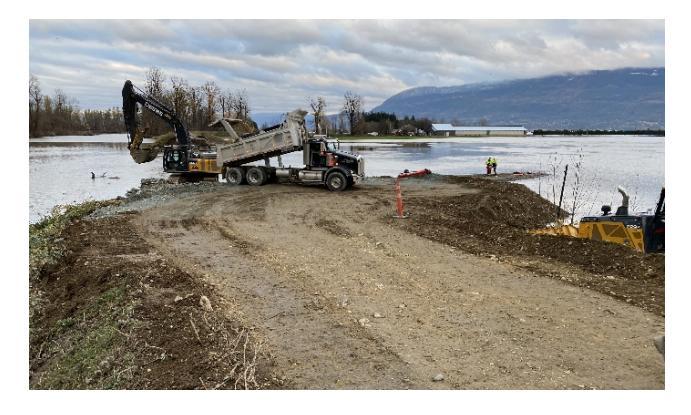
Another primary consideration is access for construction equipment to the breach site. Water will likely surround all sides of the dike at the breach site. In most instances, the top (travel) surface of the dike will just be wide enough to accommodate travel in one direction (see Fig. 9). A review of existing information including as-built drawings, if available, should be carried out prior to mobilizing to the breach site to assess the construction of the existing dike and whether it can support heavy construction equipment and loading dump trucks. Some of the dikes in the Lower Mainland and Fraser Valley of BC, were originally constructed as agricultural dikes. In several instances these early dikes were constructed using dredged materials from the adjacent waterbody that consisted of fine-grained soils and as such are prone to disturbance and deformation under loading and inclement weather (see Fig. 10).

Fig 9. Limited access to the main breach site.

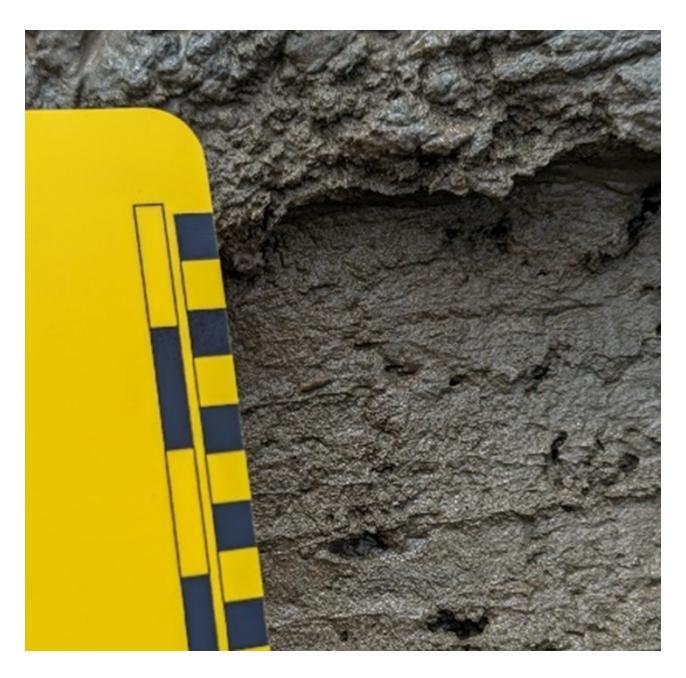
Fig 10. Example of poor-quality, fine grained dike fill material.

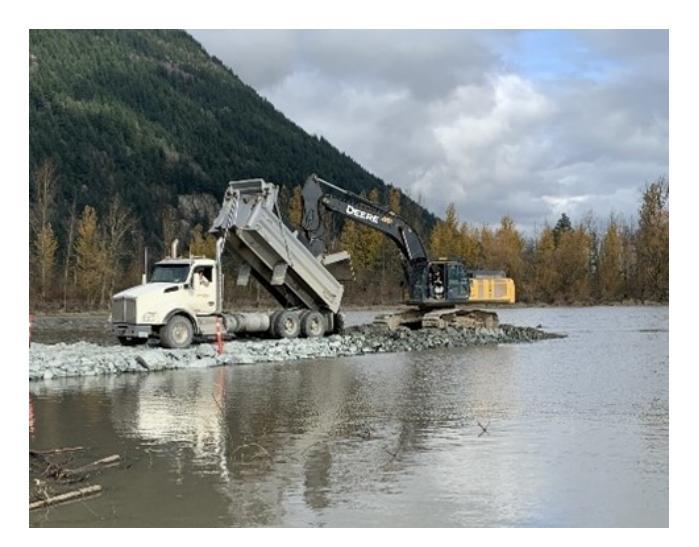
Fig 12. Initial closure of the main breach.

original emergency repairs. Fig. 12 shows construction of the initial crossing of the main breach of the Sumas River Dike and different zones of crushed rock fill sizes are shown in Fig.13 as the dike is being raised.

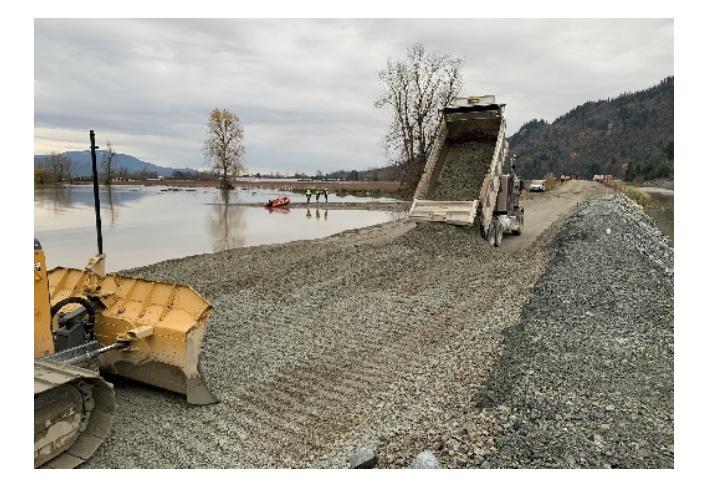
Fig 13. Raising and widening the closure of the main breach.

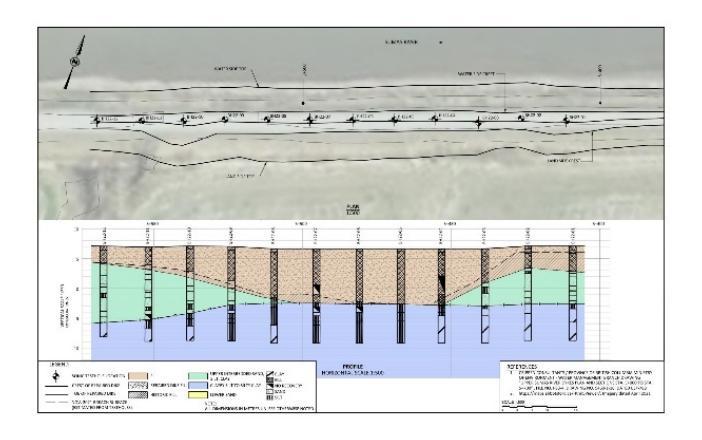
A summary plot, like that prepared for the main breach and shown on Fig.15, is useful to establish the extent (depth and length) as part of design of the barrier and to set up a model(s) for seepage and stability analysis. Fig 15. Plot of test holes and interpreted subsurface conditions along the main breach of Sumas Dike.

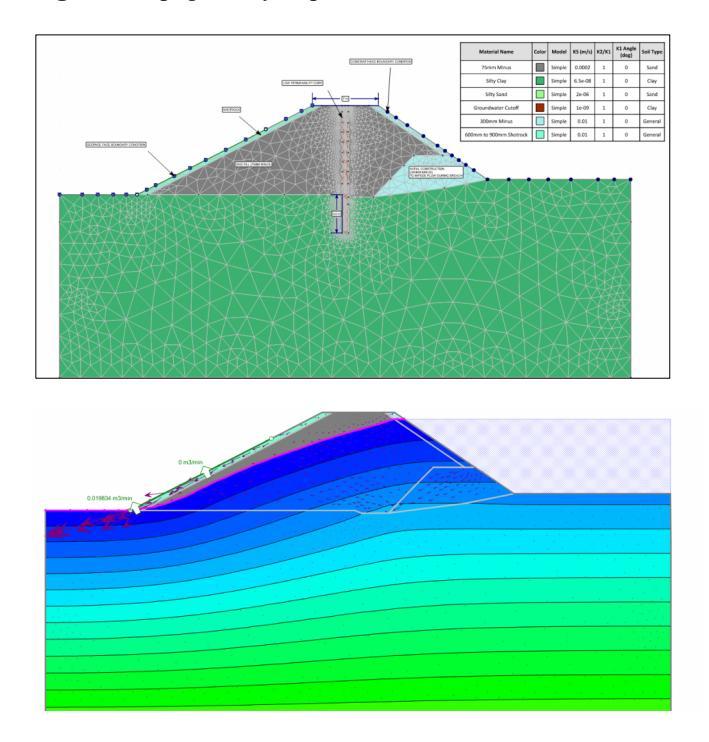
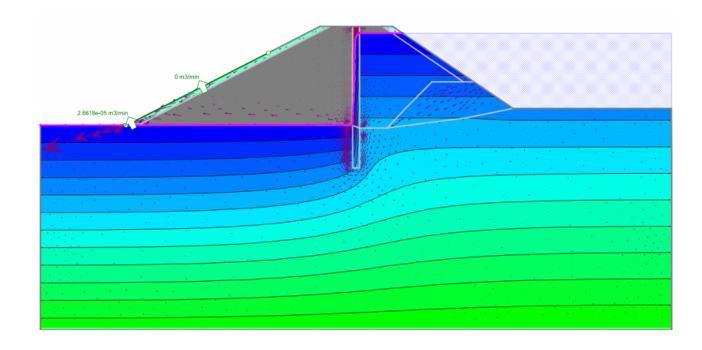
Fig 16. Seepage analysis plots for the main breach.

Detailed seepage analyses are typically carried out to assess the potential benefits of installing a low permeability barrier within the closed section of dike. Fig.16 illustrates the results of some detailed seepage analysis that was used to assess the potential benefit of installing low permeability barrier at the main beach in this case by means of Cutter Soil Mixing (CSM) technology. For the main breach, the addition of the low permeability CSM barrier lowered the seepage flows by about two (2) orders of magnitude. In addition, stability analysis should also be carried out to check dike stability if loading from the new dike mass is considerably greater than the pre-existing dike, if the foundations soils are weak and/or if seismic loading needs to be considered. Specific details on the design of the CSM barrier installed for the main breach of the Sumas River Dike are provided in Mylleville et al., 2023.

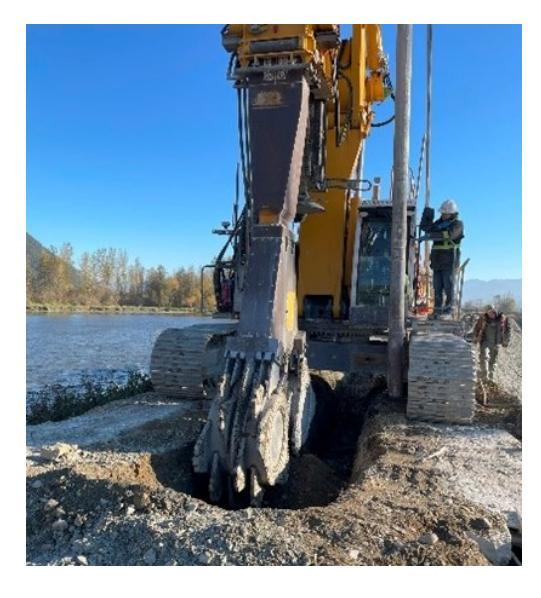
Fig 17. Installing CSM barrier at the main breach.

For the main breach of the Sumas River Dike, one of the key considerations in selecting the preferred option to reinstate a low permeability barrier in the breach closure was that, as much as possible and practical, the preferred option should minimize the need for de-construction. Cutter Soil Mixing (CSM) technology (a type of deep soil mixing) was selected as the preferred option to reinstate a low permeability barrier within the breach closure. CSM is one of several proven and locally available methods for deep soil mixing and has been successfully used in other similar barrier applications (Arnold et al., 2011, Holzman et al., 2019 and others). Fig. 17 shows the CSM rig installing the low permeability barrier at the main breach.

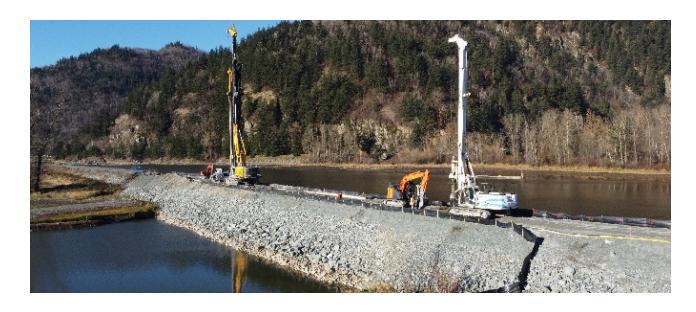
During construction of the CSM barrier at the main breach, larger pieces of crushed rock were encountered within in the finer crushed rock/gravel zone and posed a significant challenge for the CSM equipment resulting in delays and equipment damage. Despite best efforts during construction of the emergency repair, some larger pieces of crushed rock were present in the zone intended to be constructed of smaller sized crushed rock/gravel. The contractor mobilized appropriate drilling equipment to pre-auger the remaining portion of the barrier alignment and remove larger pieces of crushed rock that were obstructing progress. Further details on the CSM barrier construction and how challenges were overcome at the main breach of the Sumas River Dike are provided in Mylleville et al. 2023. Fig. 18 shows the CSM Rig and pre-augering drill situated on the main breach site.

Fig 18. CSM rig and pre-augering drill at the main breach.

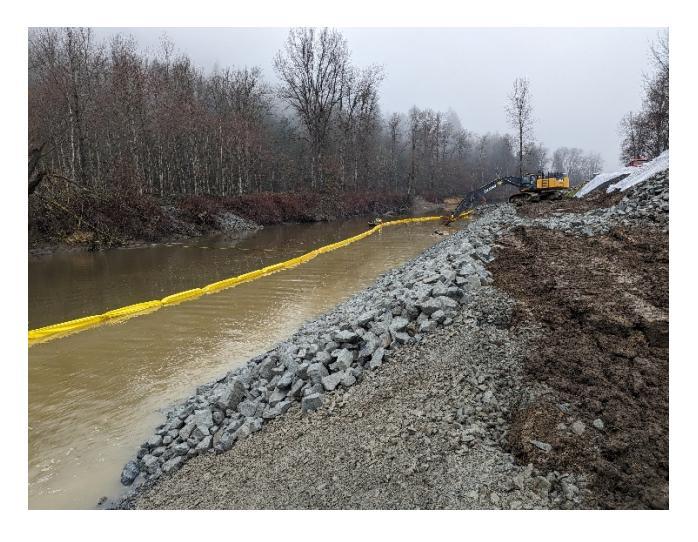
Fig 21. Reinstatement of eroded section of Sumas Dike.

The contractor should exercise care when placing materials directly onto the slope to prevent segregation. In many cases, site conditions and regulatory requirements (e.g., fishery window) may necessitate placement of filter layer(s) and rip rap under water. In this scenario, consideration should be given to increasing the thickness of the filter layer(s) and working with an experienced contractor to develop an appropriate placement methodology to ensure the intent of the filter design is met. Reinstatement of sections of the Sumas Dike that were eroded during the November 2021 event are currently underway (Fig. 21).
