Considerations in the design and construction of dike breach repairs

Brian L.J. Mylleville, Ph.D., P.Eng. Senior Geotechnical Engineer, Kontur Geotechnical Consultants Inc.

Dike Breaches – Sumas River Dike, Abbotsford, BC

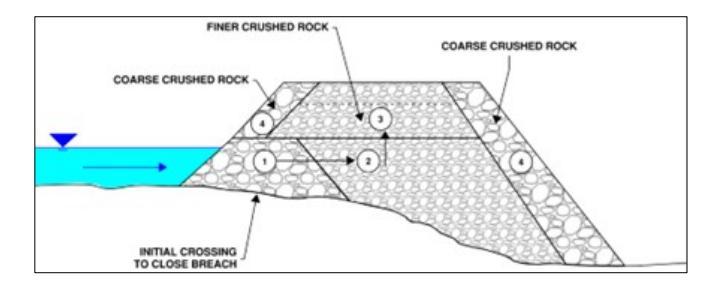
Fig 11. Schematic of initial closure of breach and construction sequence.

If the breach is closed with mineral fill in conditions of flowing or standing water, then it will be impossible and impractical to use fine-grained soils; attempting to do so would likely be disastrous. Larger crushed rock (riprap sized or similar) can be used to construct an initial crossing (closure) to stop open flowing water through the breach (see 1) in Fig. 11); however, seepage flow will continue through the initial closure due to the porous nature of the coarse crushed rock. Once the open flow is stopped then smaller sized crushed stone (i.e., 75mm minus) can be used to widen and build up the closure (see 2 and 3 in Fig. 11, respectively) while at the same time reducing seepage flows. It should be recognized that the use of the finer crushed rock (gravel) within the central portion of the dike closure crosssection may be crucial to allowing for installation of a low permeability barrier or core as part of the remedial phase of the work. Failure to do so would likely result in significant challenges for installation of a low permeability barrier, possibly requiring deconstruction of a portion or most of

original emergency repairs. Fig. 12 shows construction of the initial crossing of the main breach of the Sumas River Dike and different zones of crushed rock fill sizes are shown in Fig.13 as the dike is being raised.

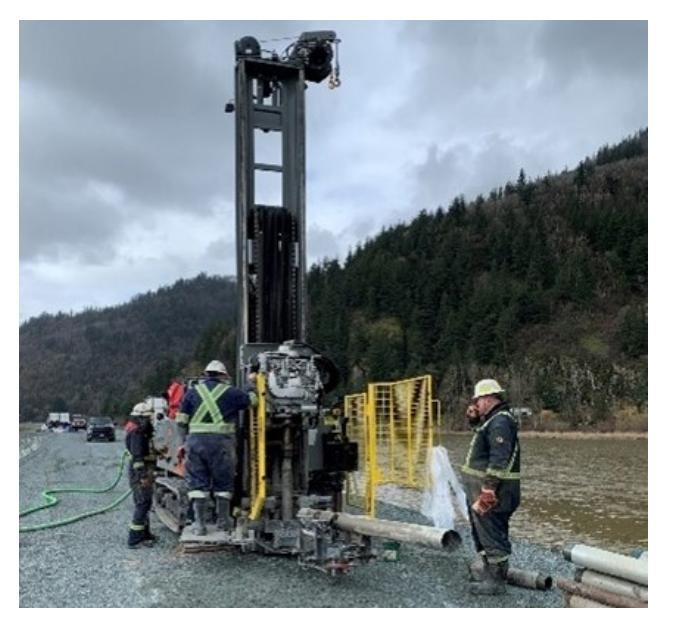
Fig 14. Drilling exploration at the main breach.

Once the breach is closed, as previously described, then there is a good possibility that remedial repairs will be required to install a barrier (core) so that the repaired section can be reinstated to function as a dike. Design of the remedial measures will, in most instances, require a geotechnical exploration be undertaken to assess the depth and extent of the new fill placed as part of the emergency repairs, the characteristics of the underlying foundation soils and the presence or absence of pieces of larger crushed rock within the central portion of the dike that could influence the choice of technology used to install a low permeability barrier (core). A detailed drilling exploration was carried out at the site of the main breach of the Sumas River Dike (see Fig.14).

The results of the field exploration can be used to develop a model of the breach site confirming the depth and extent of the breach, and in turn used to establish the required extent and characteristics of the barrier. The field exploration for the main breach of the Sumas River Dike included continuous sampling of the new fill using sonic drilling methods to confirm the presence or absence of pieces of crushed rock within the central portion of dike section. In addition, electronic Cone Penetration Testing (CPT) probes were extended through the crushed rock fill and down into the foundation soils beneath the breach to obtain data that could be used to assess the hydraulic conductivity and strength of various soils strata encountered.

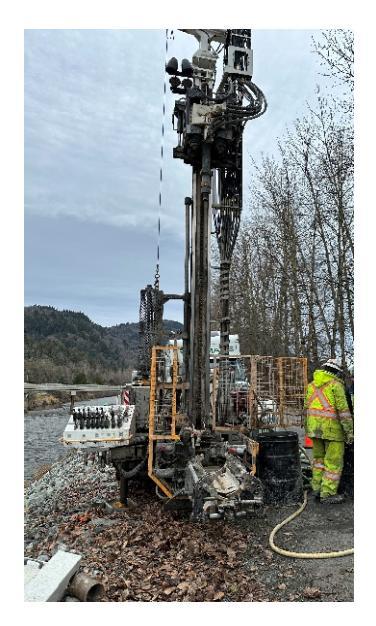
Fig 20. Sonic drilling to obtain representative samples of dike fill.

In addition to the aforementioned breaches, the events of November 2021 also resulted in localized damage of the Sumas Dike, which did not result in catastrophic failure of the dike but still require special attention and repair. Much of the flood-induced damage was bank erosion of variable severity and extent along the water side of Sumas Dike. In addition, there were also localized slope failures in which the water side slope was partially washed away but did not cause a complete breach of the dike. In both scenarios, the dike can be reinstated without the need to deconstruct the dike. Rather, a protective layer of appropriately sized rip rap can be placed on the slope to reinstate the dike and protect against potential future erosion. Depending on the gradation of the existing/remaining dike fill material, one or more granular soil filter layers may be required between the existing finer-grained dike fill material and the outer riprap protective layer to mitigate potential internal erosion/piping. It is essential to obtain representative samples of the dike fill along the affected section(s) of the dike from which sieve and hydrometer testing can be completed for use in the analysis and design of the filter layer(s). Sonic drilling methods proved to be successful in obtaining continuous samples of the affected sections of the Sumas Dike in 2022-2023 and inform filter design(s) (Fig. 20).
